TECHNICAL SERVICE BULLETIN

Lack Of Heat Or Cooling From The Cabin Vents - Temperature Door Or Door Actuator Binding/Inoperative - DTC B1081:07

21-2144

Ford
2017-2021 F-Super Duty
2015-2021 F-150

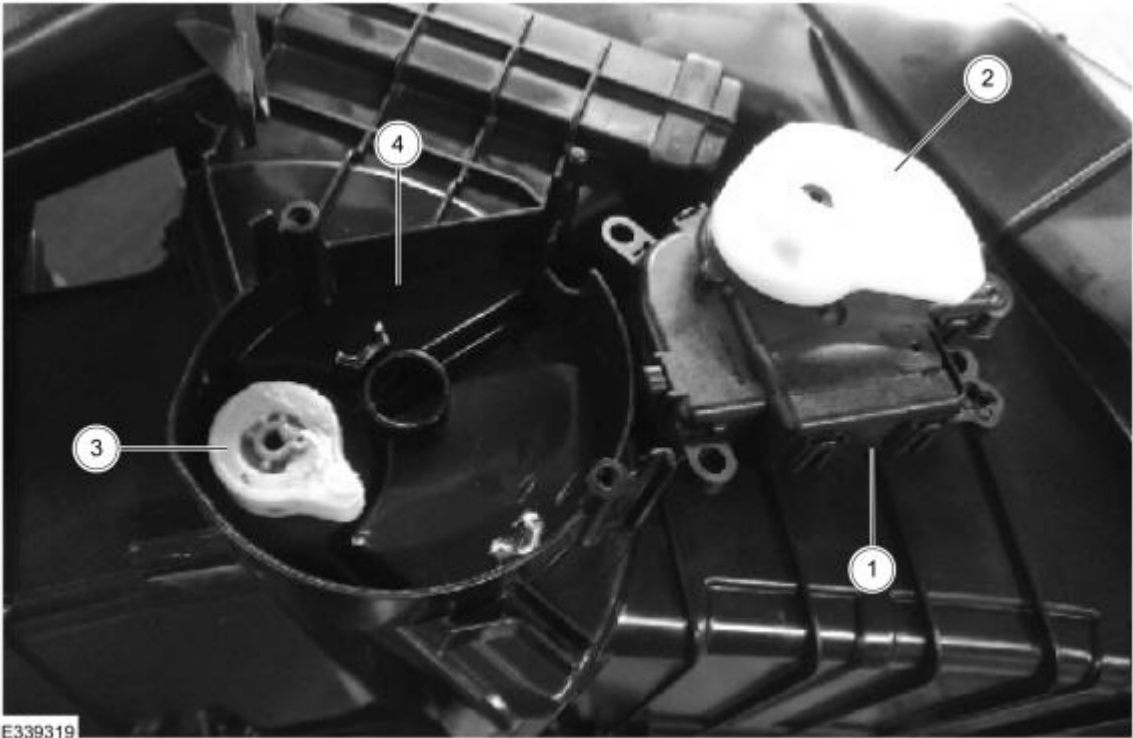
E339319

NOTE: Do not remove the cam follower from the climate control housing blend door. It is critical to be gentle when cleaning the cam follower as damaging the temperature blend door shaft will require replacement of the climate control housing. (Figure 1)

- Gently wipe the driver side temperature blend door actuator, cam, and cam follower attached to the climate control housing blend door to remove any debris and existing lubricant.

- 2. Replace the driver side temperature door actuator and cam. Refer to WSM, Section 412-00. Lubricate the new cam and cam follower pin using Motorcraft® HVAC Duct Component Grease.
- 3. Reassemble per WSM. Test the temperature blend door operation. Does the system operate properly?
 - (1). Yes - repair is complete.
 - (2). No - proceed to Procedure B.
